## ON THE MULTISCIPLINARY APPROACH FOR THE EVALUATION OF THE STRUCTURAL BEHAVIOUR OF HISTORIC CONSTRUCTIONS

### Abstract

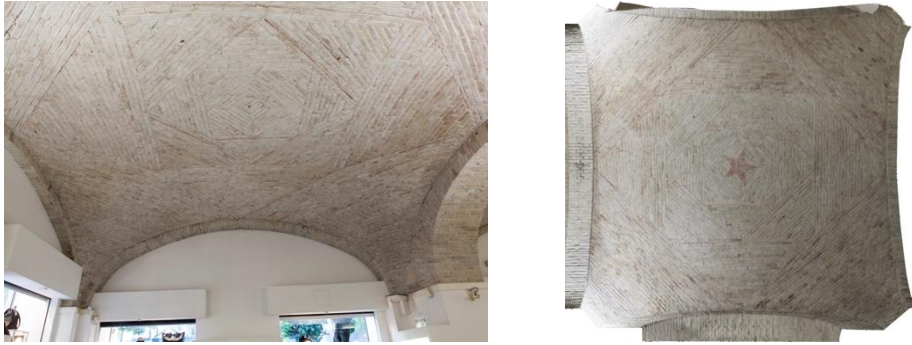
As shown in Figure 1, the vault is characterized by several brick arrangements and by a lowered shape, that is nearly flat in correspondence to the crown. Four boundary arches limit the plan dimensions that are 5.88 x 5.68 m; the arch's maximum rise is 1.48 m at the key bricks. The vault has a total thickness of 12 cm, except at the lower sections corresponding to

Figure 1: The masonry vault.

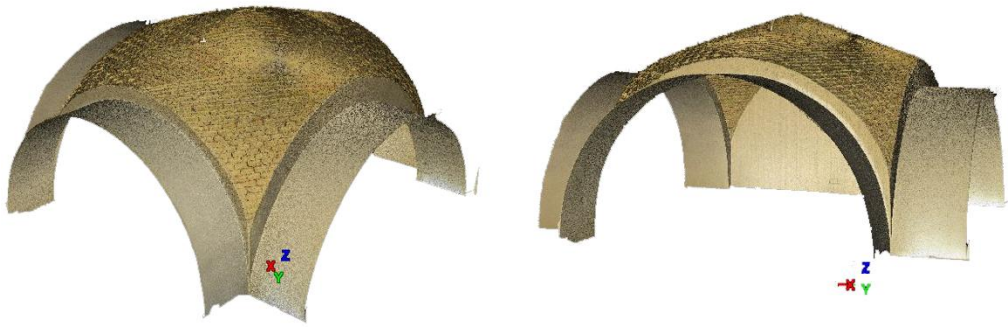
The vault geometries were reconstructed through a laser scanner survey conducted with the Leica Laser Scanner HDS 7000 (Figure 2). Four scans were performed to capture the precise geometry of the vaults and the bricks pattern. The acquired geometric data was then integrated with the chromatic features obtained by a photogrammetric survey.

Figure 2: The vault geometry obtained from laser-scanner surveys.

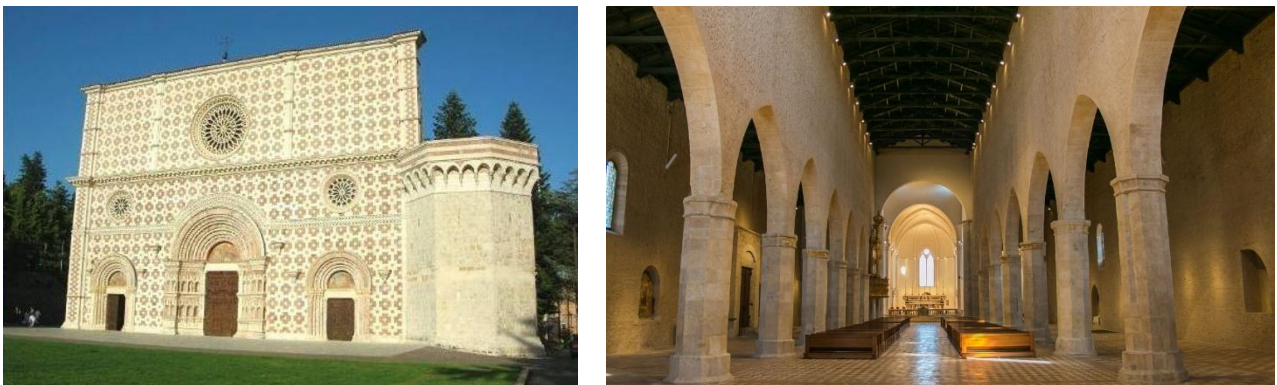
Figure 6: Santa Maria di Collemaggio Basilica.

Santa Maria di Collemaggio Basilica was built in the late XIII century and represents an outstanding example of Romanesque architecture. Throughout its history, the Basilica has undergone various architectural and structural changes, often necessary due to the damage caused by seismic events [16,17]. The Basilica is characterized by the presence of three aisles with two lines of octagonal columns (Figure 7).
